MARTIN COUNTY TRANSIT SERVICE BUS STOP ADA ASSESSMENT FINAL REPORT

March 25, 2015

Martin County Transit Service
2401 SE Monterey Rd,
Stuart, FL 34996

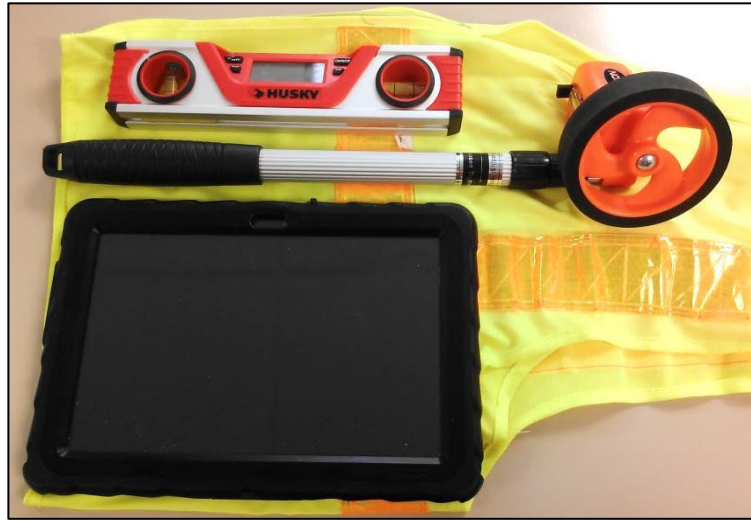
Figure 2-1 Data Collection Tools

Figure 2-1 illustrates the primary equipment utilized by the surveyor teams during the data collection process.

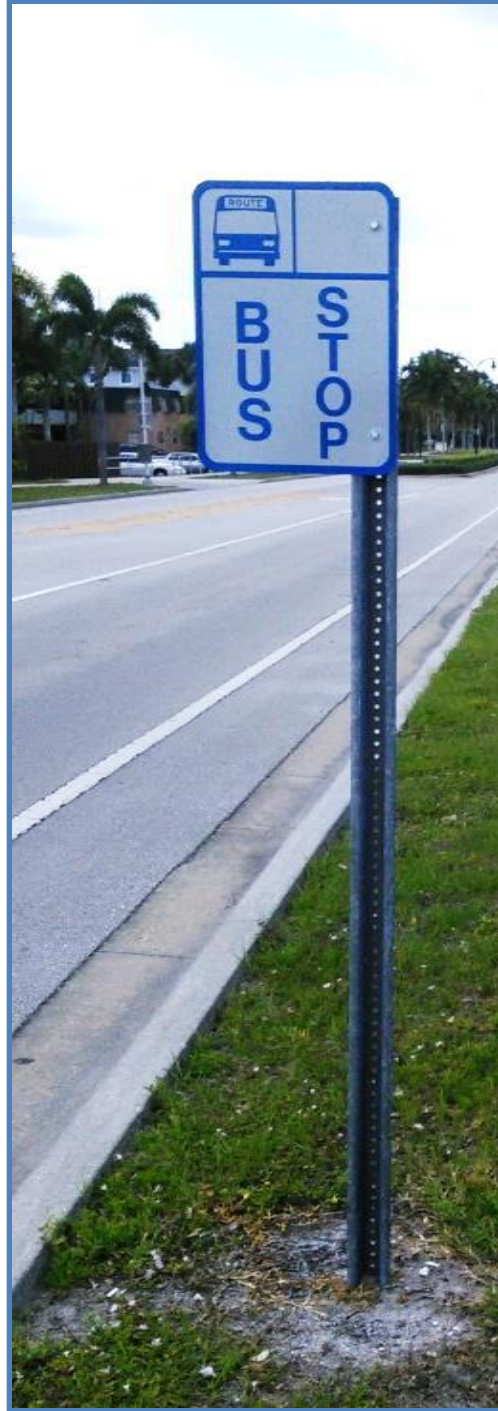
Figure 3-3 MCPT Bus Stop Sign

As shown in Figure 3-3, the MCPT bus stop sign meets the requirements, as specified in section 3.4. All new signage will be located 80” from the ground to the bottom of the sign. The signs will be two faced and will be oriented towards the pedestrian path. In addition, all bus stops that serve more than one route should, at a minimum, also include a route number.

In general, the typical sign design for MCPT meets the requirements of the ADAAG/FAC. There are 10 stops without a MCPT bus stop sign and 0 MCPT bus stops that have a bus stop sign that is not properly mounted. Therefore, 10 bus stops have a MCPT bus stop sign deficiency at the bus stop. It was also noted that the stops that appear to serve more than one route were missing the bus route numbers on the sign.

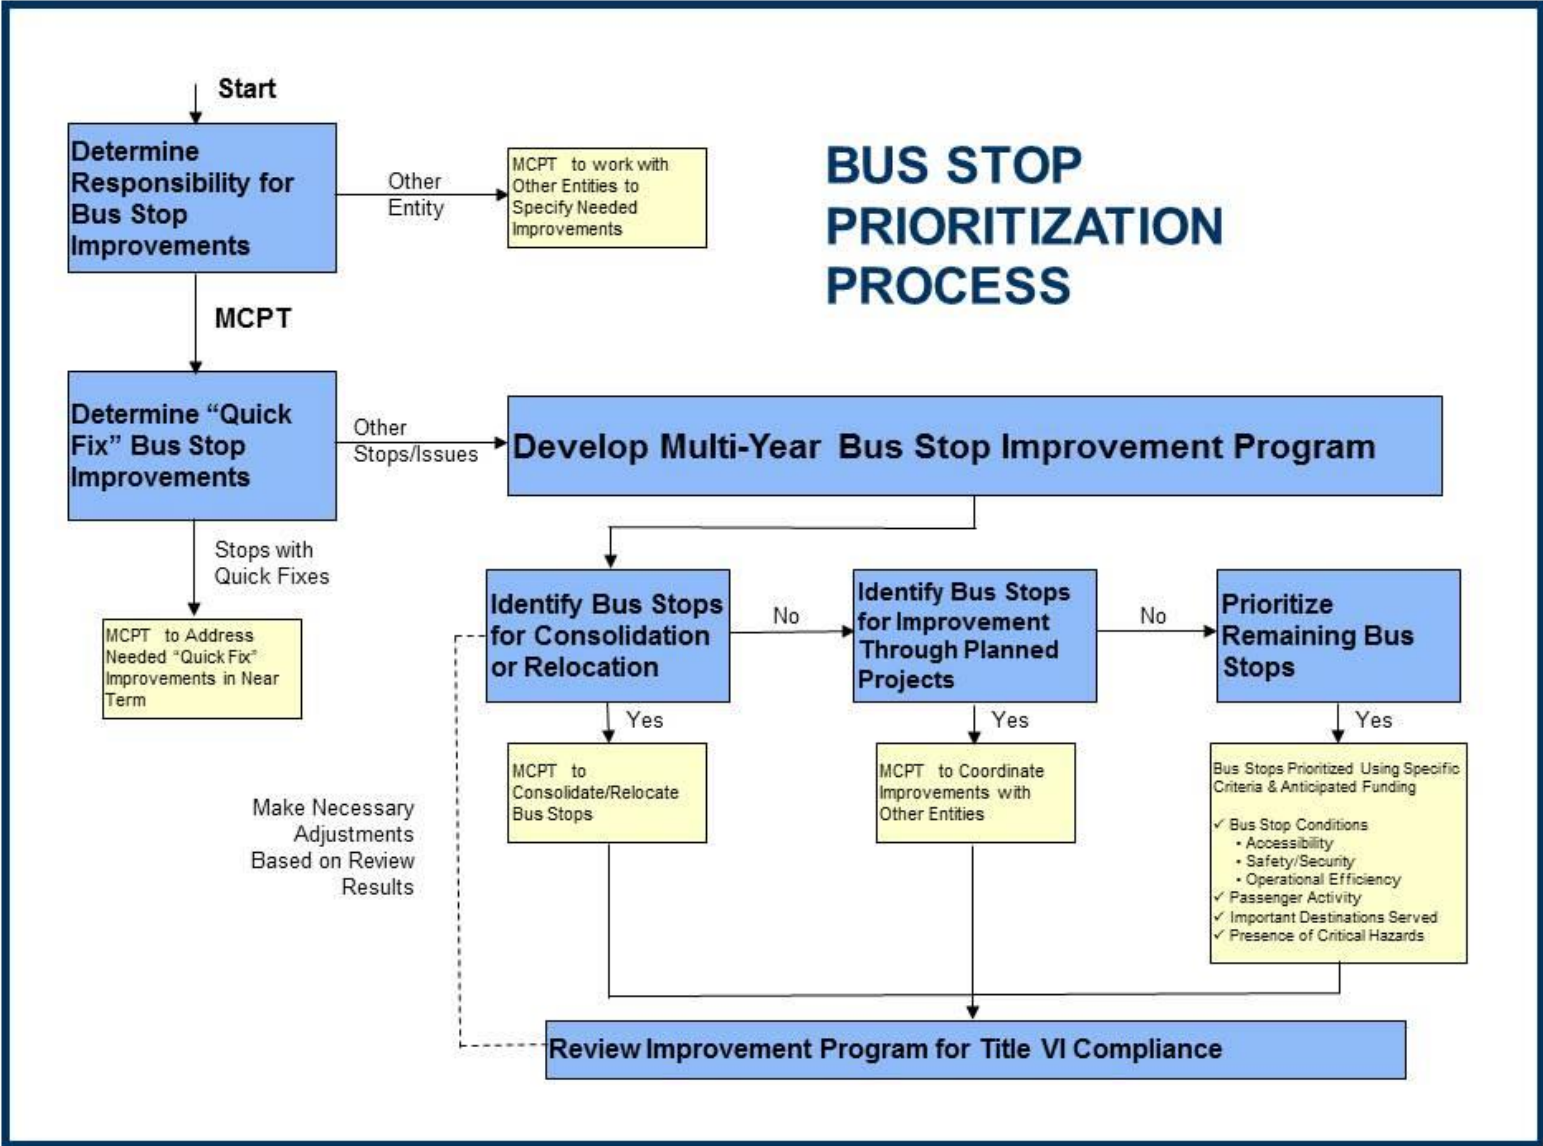
Figure 4-1 Prioritization Process Flow Chart

The first step in developing the phased implementation plan was to determine which improvements are the responsibility of MCPT versus those improvements that are the responsibility of other entities. Although many of the identified potential bus stop improvements will need to be addressed by MCPT, it also is the case that a number of the recommended improvements may fall under the responsibility of other entities such as FDOT, Martin County, Stuart and/or other public and private entities. Based on the responsible entities identified for each type of improvement, which are presented in Table 4-1, those improvements identified to be the responsibility of an entity other than MCPT are removed from the list of improvements that are to be included in the phased implementation plan. These improvements will be considered separately, as MCPT will need to coordinate with these entities to specify the needed improvements and determine the best course of action to complete them in an appropriate timeframe.
